## Multiple load cell errors and Zeroing errors

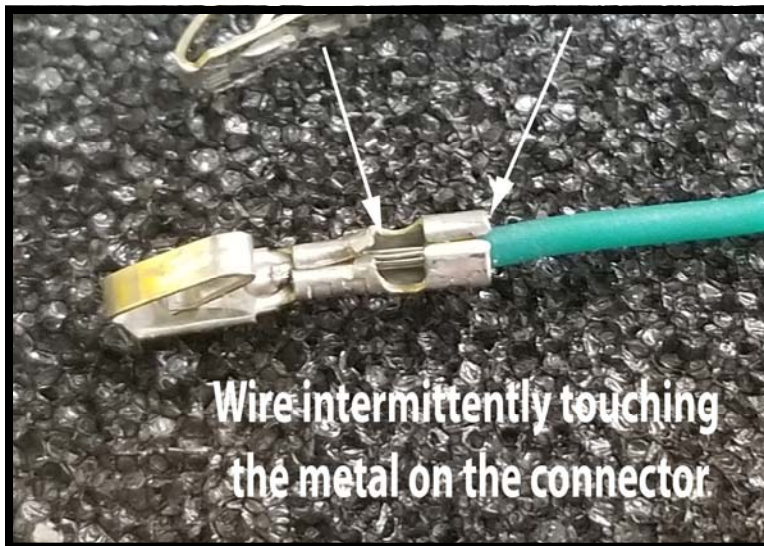
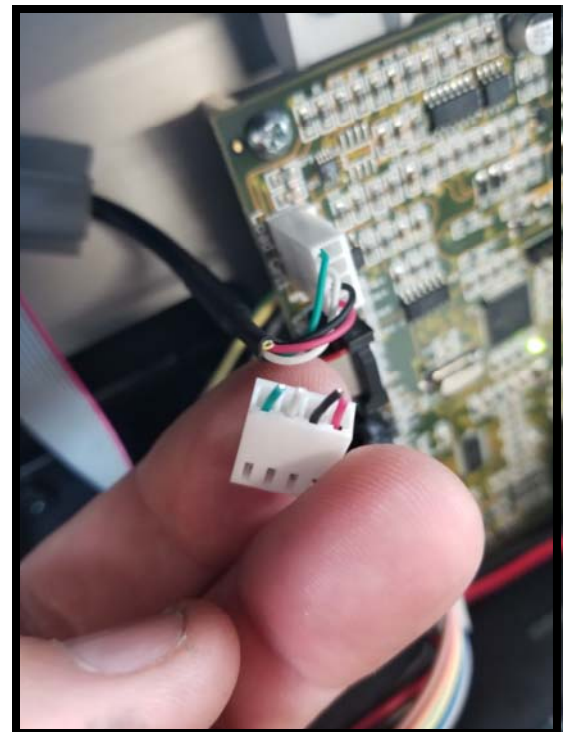
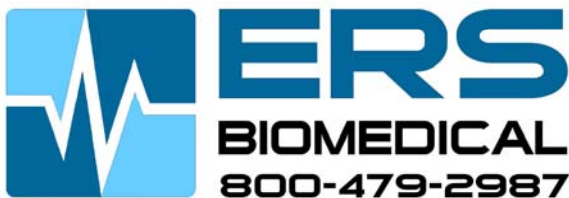
It has become evident that during manufacturing of the load cells, that the crimping is not perfect, I have noticed many different errors pointing to the load cell and the zeroing of the load cell. 8 out of the last 10 successful service calls regarding these types of errors has been simply to cut off the connection to the load cell and crimp new connectors to the wiring and re-insert in the 4-pin connector.
